Accelerated Road Testing using GE-NANO

In January this year, the Council for Scientific and Industrial Research (CSIR) completed accelerated road testing using a Heavy Vehicle Simulator (HVS) on road D1884 near Vereeniging.

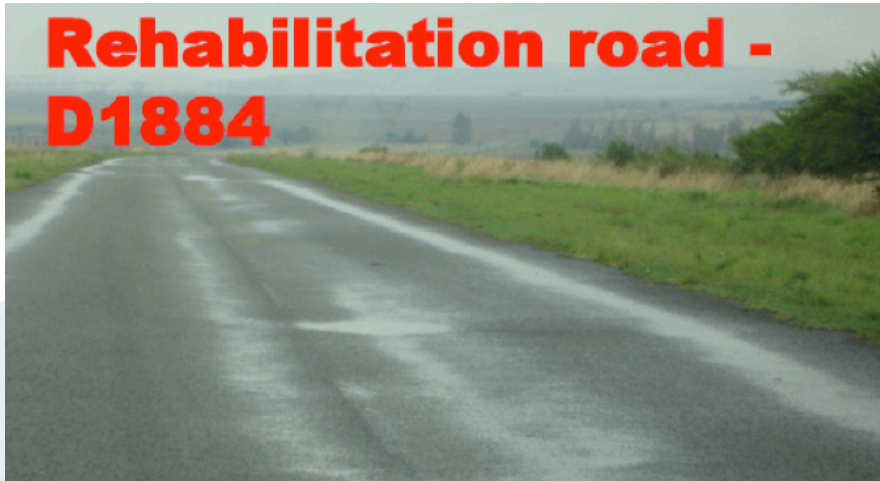
Gauteng Province:
GPDRT.
Heidelberg West:
Road D1884 -
Rehabilitation of
rural road.
~3.0 MESA

Location of rehabilitated road.

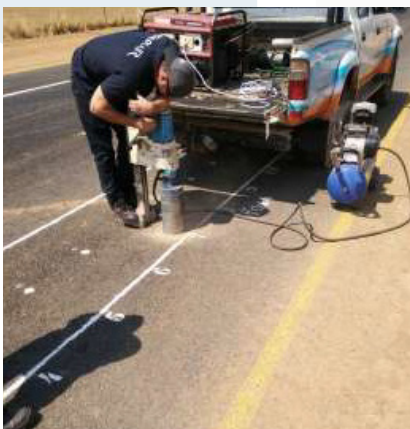
Drilling of core on prepared HVS section.

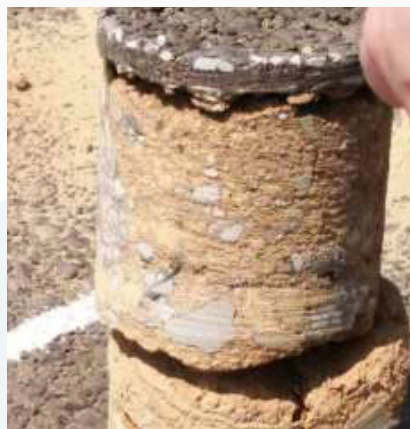
Drilled core showing the double seal, 150mm NME 4 base-layer (1.5% NME) and 150mm sub-base layer (1.0% NME). (NB: NO CEMENT!)

The solution was to reuse the existing materials, which would typically be considered of marginal to unacceptable quality for reuse within the upper (base and subbase) road layers. Both the base and subbase layers were stabilised with 0,7% GE-Nano, a nano-modified emulsion (NME) containing nano-polymers for strength and nano-silanes for improved water resistance. The rehabilitated pavement therefore comprised two 150mm thick NME stabilised layers with a double seal surfacing.

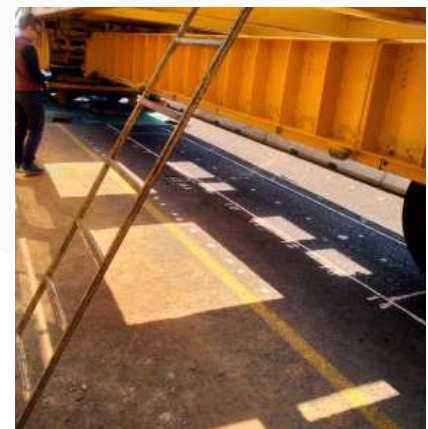
HVS test 3 days in progress.

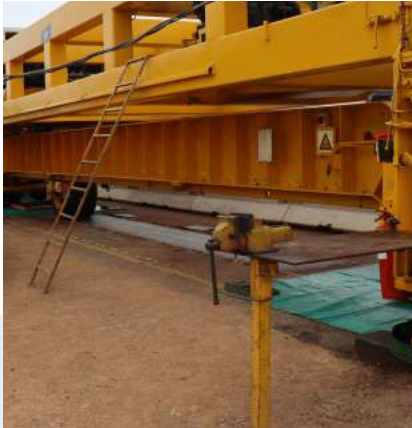
HVS testing.

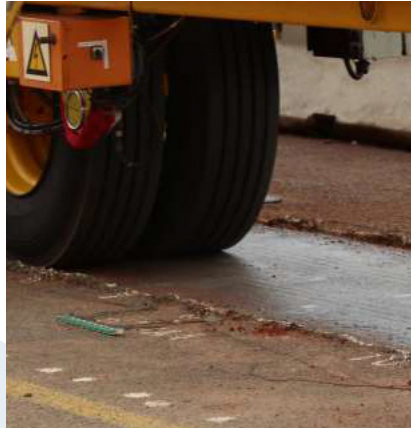
(26 November 2018) Wheel load at 80 kN (double normal). No deformation or damage to base or sub-base (seal pushed aside due to spillage of hydraulic oil from a burst pipe on the HVS) – 3 Million E80s applied to test section.

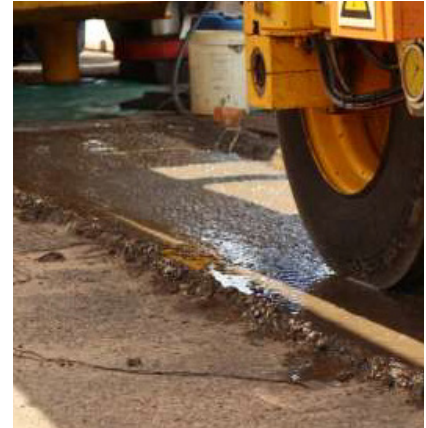
(8 January 2019) Testing at a dual wheel load of 80 kN with water applied continuously on the surfacing and to a depth of 500 mm through holes next to the test section.

Water was added continuously to the HVS section to a depth of 500mm during simulated traffic loading from December 2018 until the end of the testing on 17 January 2019. No water penetrated the base or subbase and the water had no visible effect on the behaviour/performance of the road under the simulated HVS traffic loading.

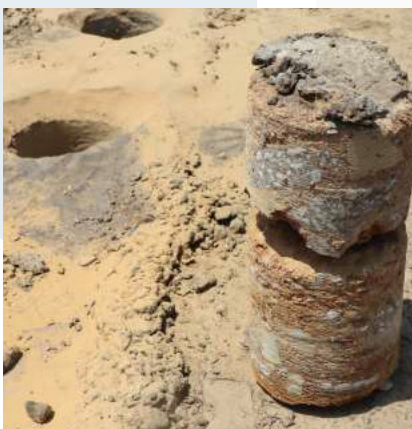
(17 January 2019) Cores drilled in the middle of the HVS test section after removal of the HVS at the end of the test after applying in excess of 7 Million E80s (more than double the design traffic loading).

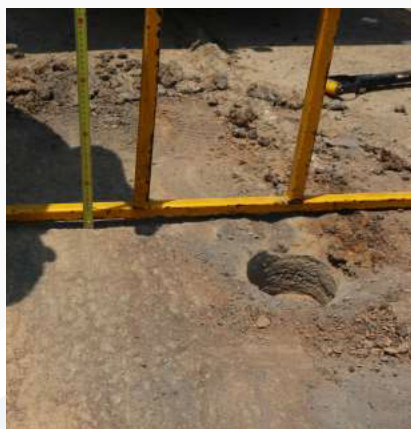
(17 January 2019) HVS test site after removal of the HVS showing less than 10 mm rut depth.

HVS testing was stopped after applying in excess of 7 million standard 8 ton axel loads with less than 10mm of rut depth being recorded and with no failure of either the base or subbase layers.

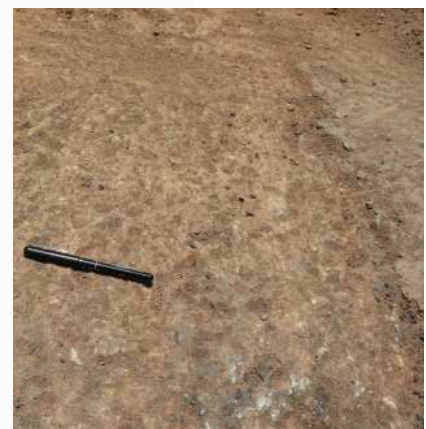
Condition of the exposed base-layer at the end of the test after removal of the surfacing with a hammer and chisel.
